**NORTH SILVER LAKE DAM
MA 00307**

**PHASE I INSPECTION REPORT
NATIONAL DAM INSPECTION PROGRAM**

**DEPARTMENT OF THE ARMY
NEW ENGLAND DIVISION, CORPS OF ENGINEERS
WALTHAM, MASS. 02154**

AUGUST, 1980

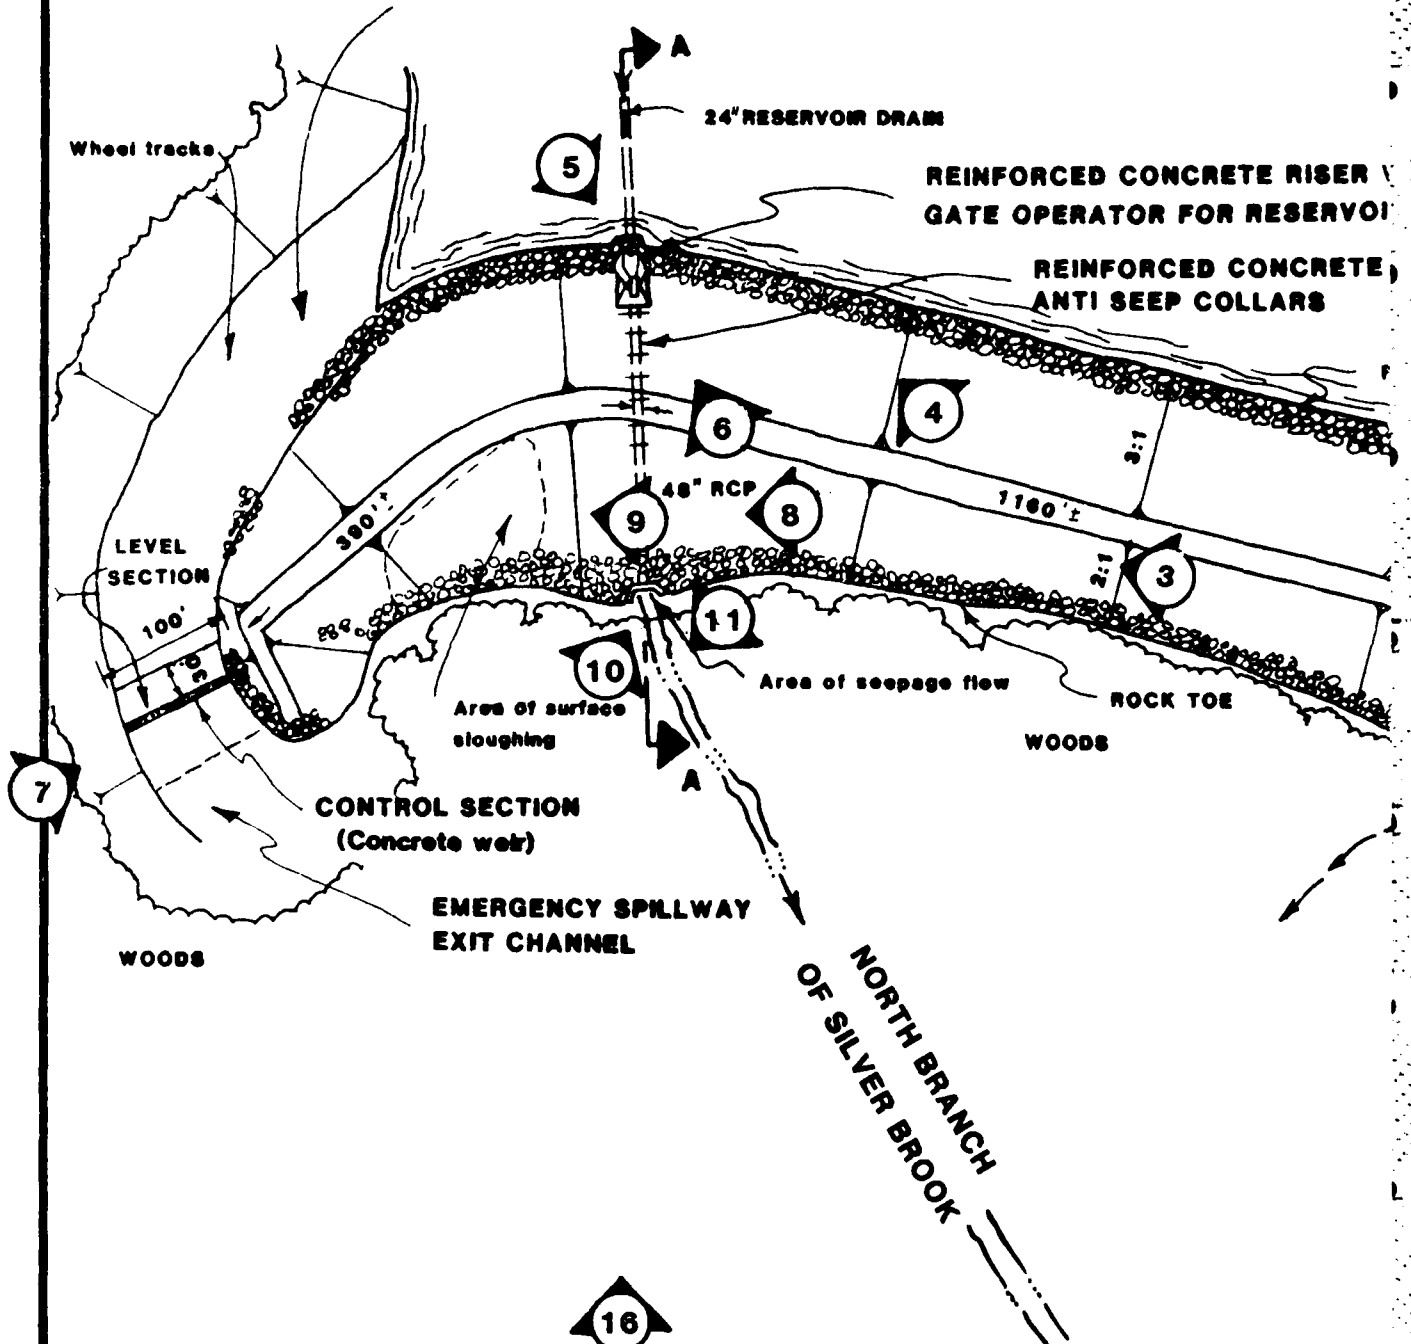
GENERAL PLAN

Visual inspection of the embankment showed serious surface sloughing on the downstream slope in an area approximately 200 feet north of the emergency spillway. (See General Plan, Appendix B-3, and Photographs 8 & 9, Appendix C.) This condition has been reoccurring since completion of the dam and has been the subject of several investigations by the Soil Conservation Service. A discussion of these investigations is presented in Section 6 of this report. Other than the surface sloughing of the downstream slope, the embankment appears to be in a stable condition. There was no obvious visible evidence of previously reported and repaired surface sloughing of the downstream slope near the north abutment. No lateral movement was apparent during the visual inspection and the vertical and horizontal alignment appeared good. No piping or boils were detected. There was no trespassing on the slopes; however, vehicle tracks on the crest of the dam trap water (See Appendix C, Photograph 2). These should be filled and graded to drain towards the reservoir. The downstream face of the embankment is vegetated with a thick growth of Crown Vetch which is approximately 10 inches high. The thickness of this growth makes it difficult to detect minor cracking, sloughing or animal burrows on the downstream face of the embankment. The riprap on the upstream berm at the normal pool elevation is in good condition.

In addition, the owner should have a qualified Registered Professional Engineer assess in detail the surface sloughing condition on the downstream face of the dam, including its potential for initiating more deep-seated slides.

The engineer should also evaluate alternative solutions to this problem. The seepage observed at the north side of the concrete headwall for the 48-inch outlet conduit should be assessed by the engineer and a monitoring and recording program established.

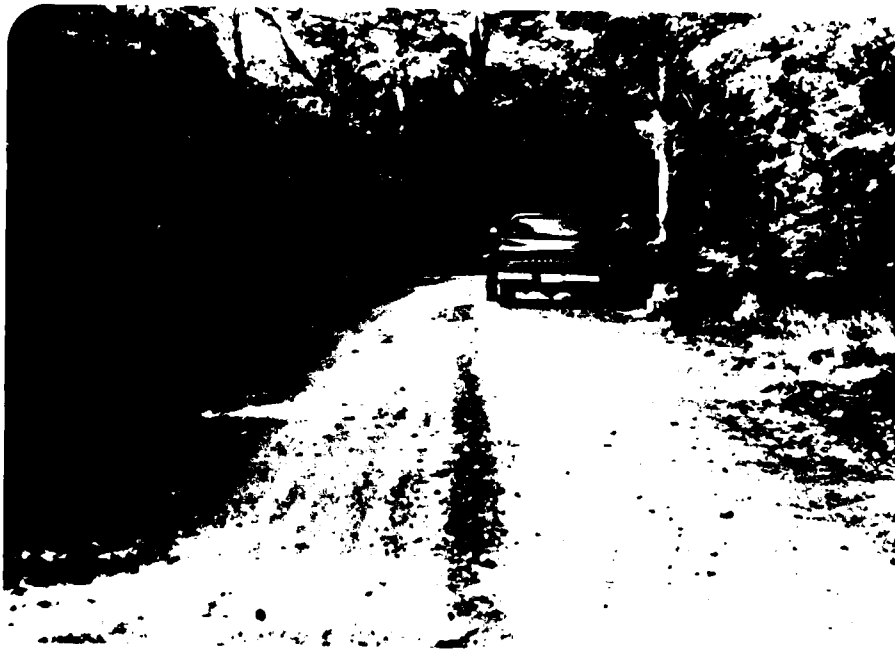
The North Branch of Silver Brook passes under Veits Road (Photographs 12 and 13) about 3000 feet downstream from the damsite, then joins the South Branch of Silver Brook which passes under Back Road approximately 1 mile downstream from the damsite. Silver Brook then flows under Route 57 about 1.7 miles downstream from the damsite where it joins the Clam River in the Village of West Boston (see Location Map). There is one residence on Veits Road approximately 300 feet southerly of the North Branch of Silver Brook crossing. This residence is about 20 feet higher than the floor of the stream channel. There are two residences in the proximity of the Silver Brook Back Road crossing located approximately 300 and 500 feet respectively from the crossing. These residences are about 35 feet higher than the stream channel at Back Road. There are several residences in the Village of West New Boston in very close proximity to the crossing of Silver Brook under Route 57. Two of these structures are next to the brook and their floor elevation is close to that of the brook (Photographs 14 and 15).

Figure 12 - View of bridge at Veits Road about 3000 feet downstream of damsite.

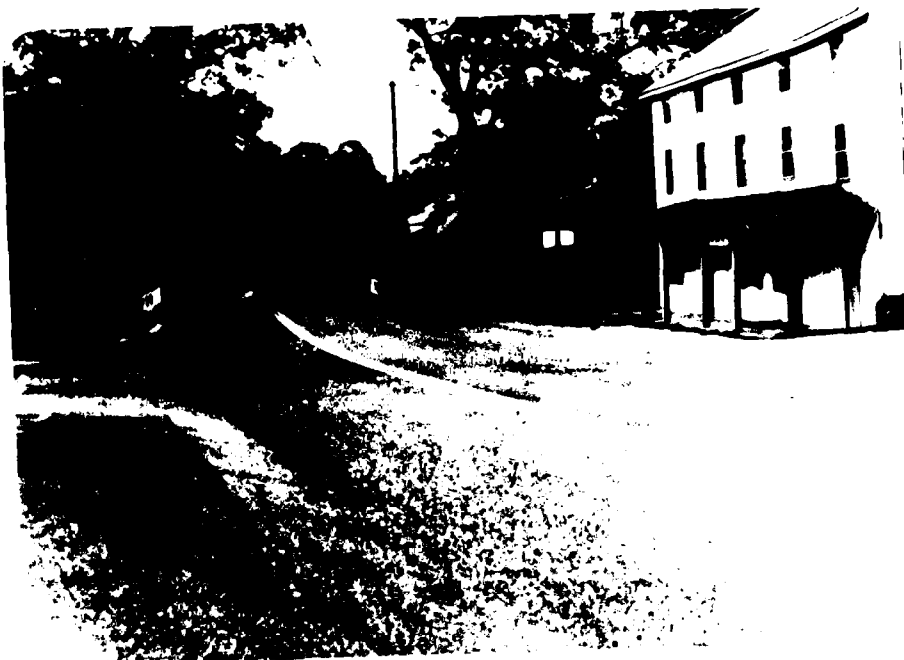
Figure 15 - View of structures near bridge at Route 57 in the Village of West New Boston. Building in foreground houses a tavern and two apartments.

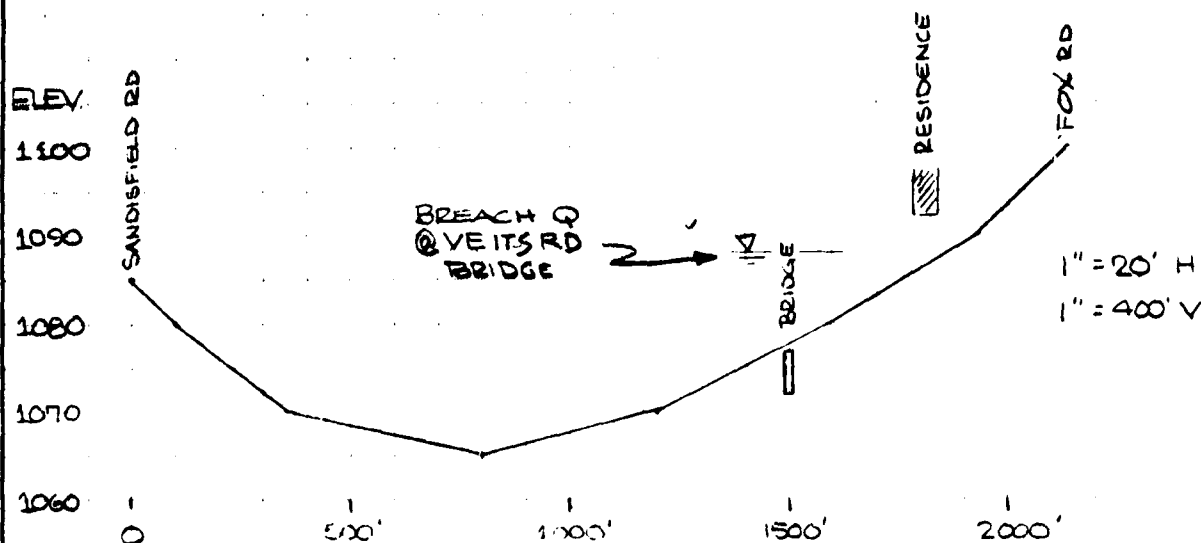
PROFILE OF VEITS ROAD

— WHEN BRIDGE CAPACITY IS EXCEEDED, WILL FLOW NORTHERLY DOWN VEITS ROAD TO ITS LOW POINT, THEN N.EASTERLY TO THE MAIN BRANCH OF SILVER BROOK.
